Eelgrass Restoration on the U.S. West Coast: A Comprehensive Assessment of Restoration Techniques and Their Outcomes

Beheshti, K. and Ward, M. 2021. Eelgrass Restoration on the U.S. West Coast: A Comprehensive Assessment of Restoration Techniques and Their Outcomes. Prepared for the Pacific Marine and Estuarine Fish Habitat Partnership.

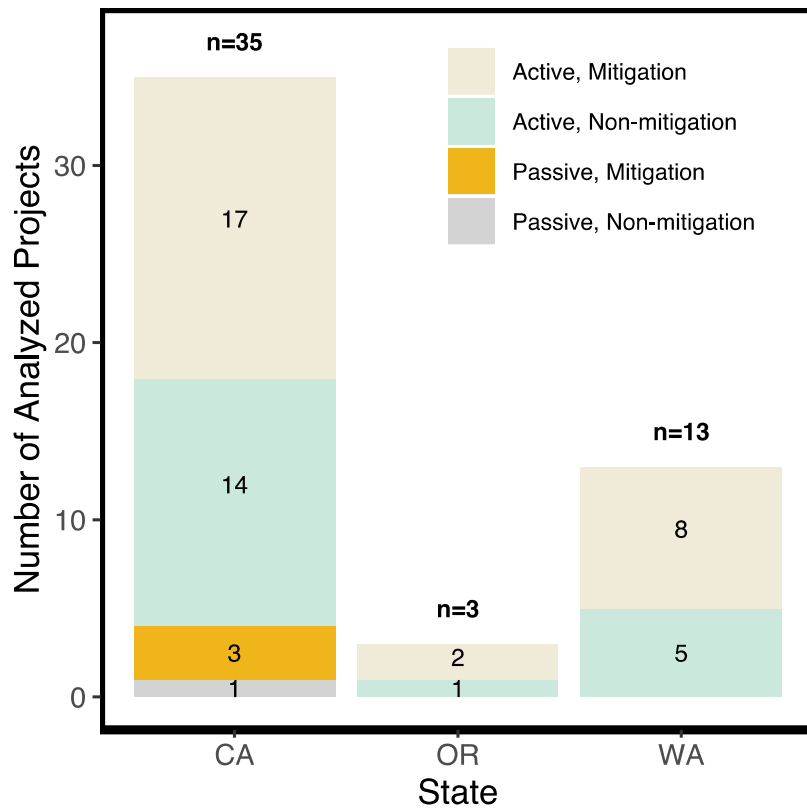
Figure 2. Number of analyzed projects (n=51) by region and type (active vs. passive, mitigation vs. non-mitigation). One project (Project 41 in Appendix A) took place in both Oregon and Washington and is represented in the above figure as having occurred in both states even though it was a single project.

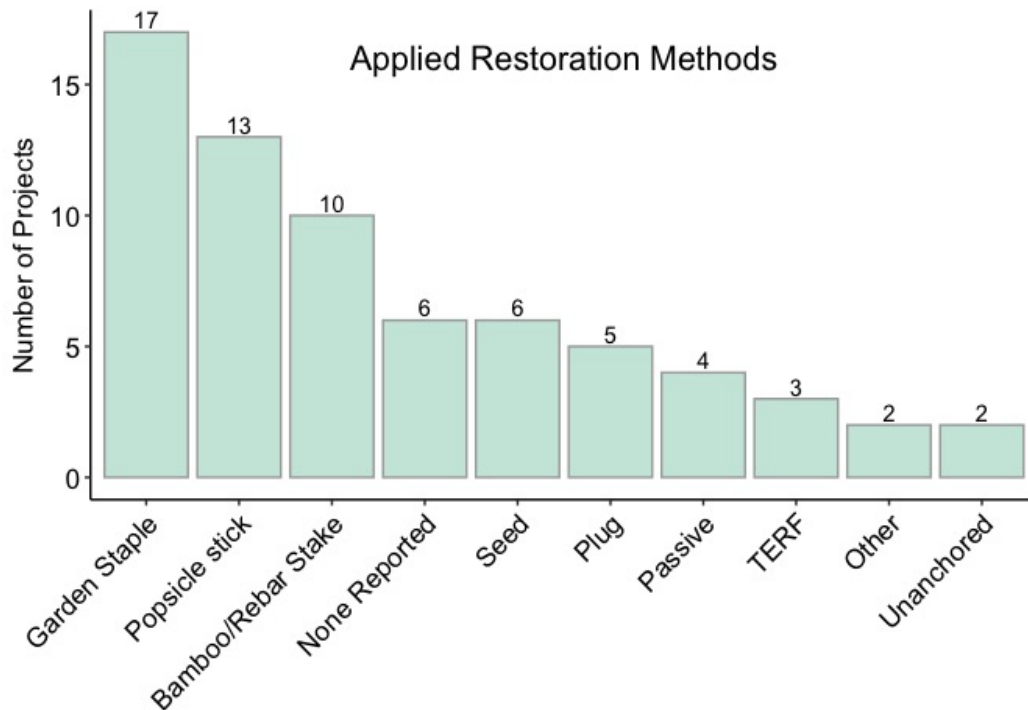
Figure 3: Summary of the methods applied in each project within the database. If a project employed more than one method, both were counted and displayed in the figure above.

Bare root transplanting involves using anchors such as garden staples, popsicle sticks, bamboo or rebar stakes (Fig. 3). In many of these methods, practitioners collect bundles of shoots, which are then fastened to the anchors on shore before being taken to the restoration site. These anchors are then pushed into the sediment along with the attached eelgrass roots and associated rhizomes. Materials used to tie eelgrass to the anchors are typically biodegradable or paper-covered metal-wire twist ties. Eelgrass was not always tied to anchors (e.g. Projects 10, 11 in Appendix A).

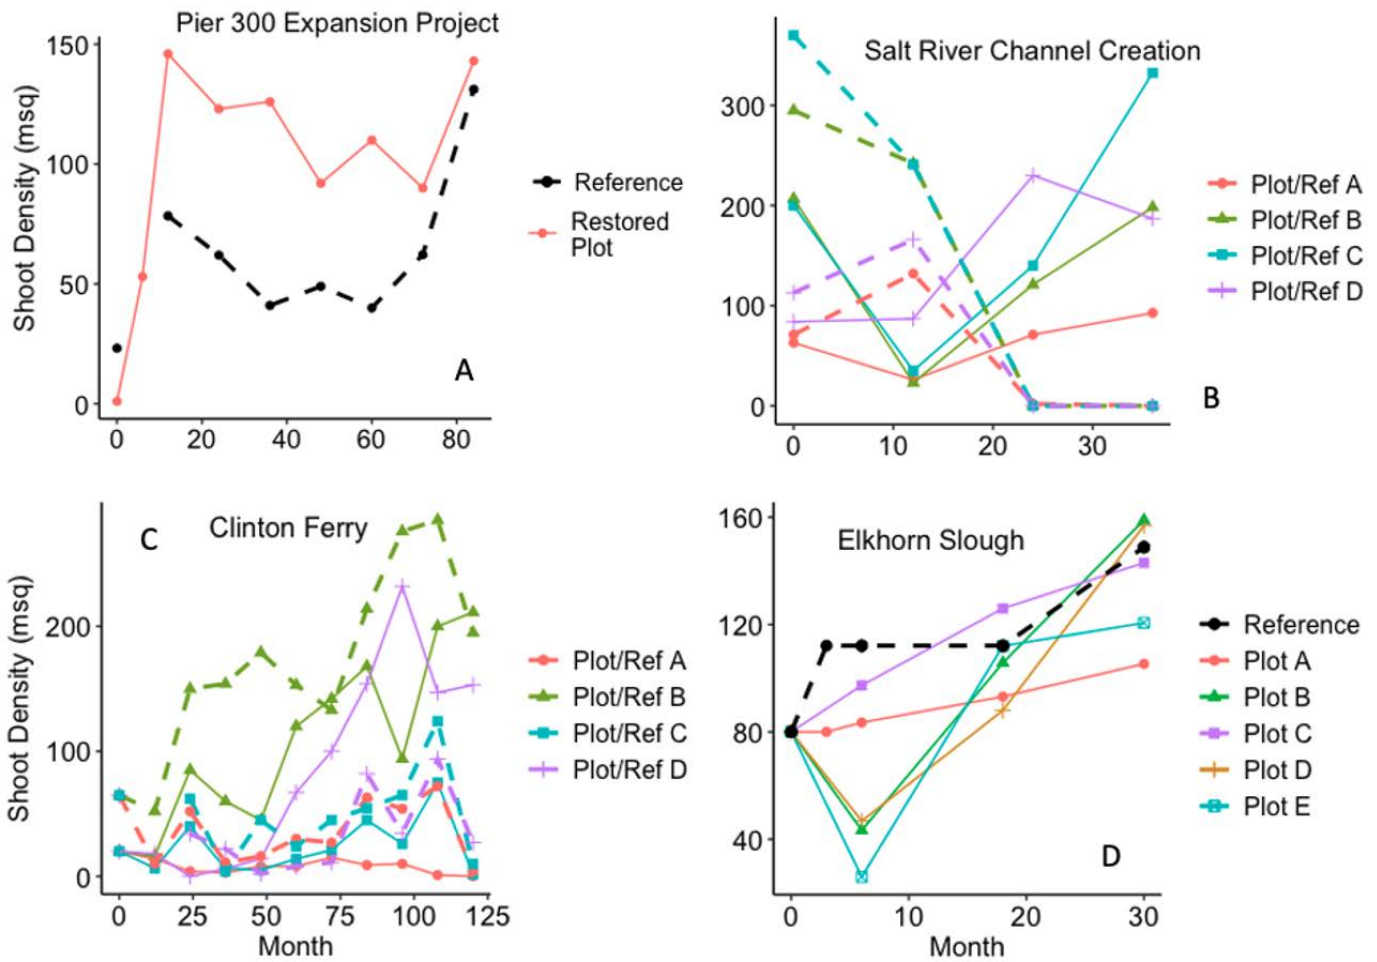
Figure 7. Time series of shoot density in restored and reference plots. A selection of projects that co-monitored reference plots (dashed lines) alongside their restoration plots (solid lines). Figures show measured shoot densities (shoots/m²) over the full course of the project monitoring period. Unconnected data points (panel A) indicate periods of monitoring lapses - where the restored plot was monitored but the reference was not. From the projects listed in Appendix A, plots A-D reference project numbers 17, 7, 42-44, and 10-11, respectively.

However, we can take a 'case studies' approach to understand the variety of project outcomes where both reference meadows and restoration plots are both monitored (Fig. 7). In some cases, projects restore multiple plots, each of which had an accompanying reference plot (Fig. 7B and 7C). In other cases, a single reference meadow was monitored to accompany one or more restoration plots (Fig. 7A and 7D). While there is considerable variability, reference plot and restoration plot shoot densities often change in similar ways over the course of the monitoring periods. However, this is not always the case as can be seen in the Salt River Channel Creation project (Fig. 7B), a passive restoration project, where reference areas within the project nearly all disappeared, despite success within the restored plots.

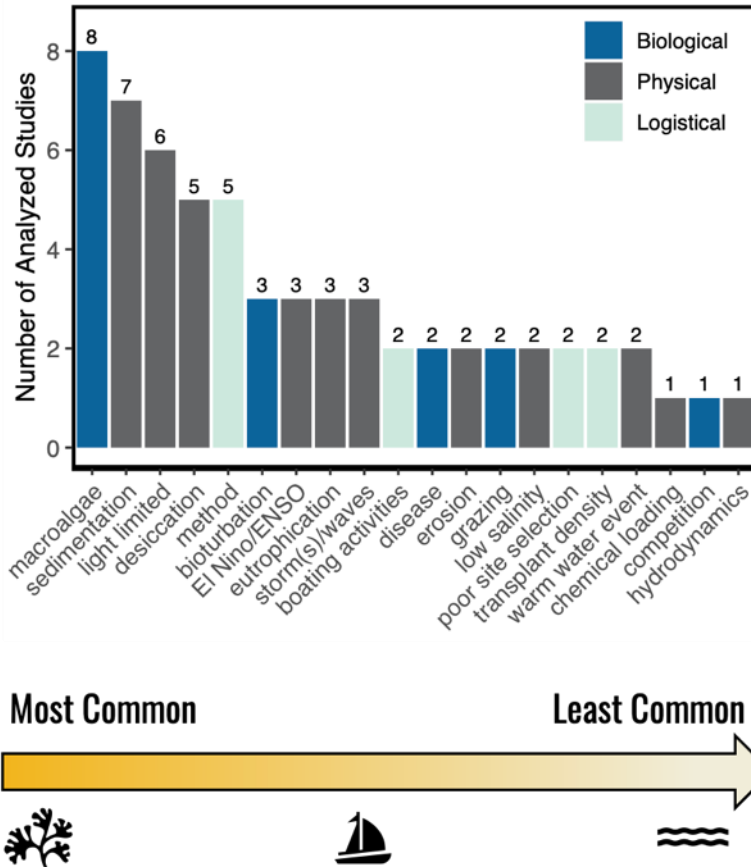
Figure 8. Cited reasons for restoration failure or loss or transplants. Projects that cited losses or failure at the project or plot level are represented in the graph to the left. The associated table lists each of the categories from most to least commonly cited reasons for failure or loss of transplanted or restored habitat. An additional 13 projects met their project goals and 14 projects did not include any known or suspected causes of project failure or loss, both of which are not represented in the above figure. Table 4 breaks up the drivers of loss and/or failure by state. For a full list of projects included in this figure and Table 4, see Appendices A and D.

that the majority of cited factors were physical (n=35), while the rest were either biological (n=17) or logistical (n=11). Macroalgae was the highest cited factor of eelgrass loss (n=8), followed by sedimentation (n=7) and light-limitation (n=6). An additional 13 projects met their project goals and 14 projects did not

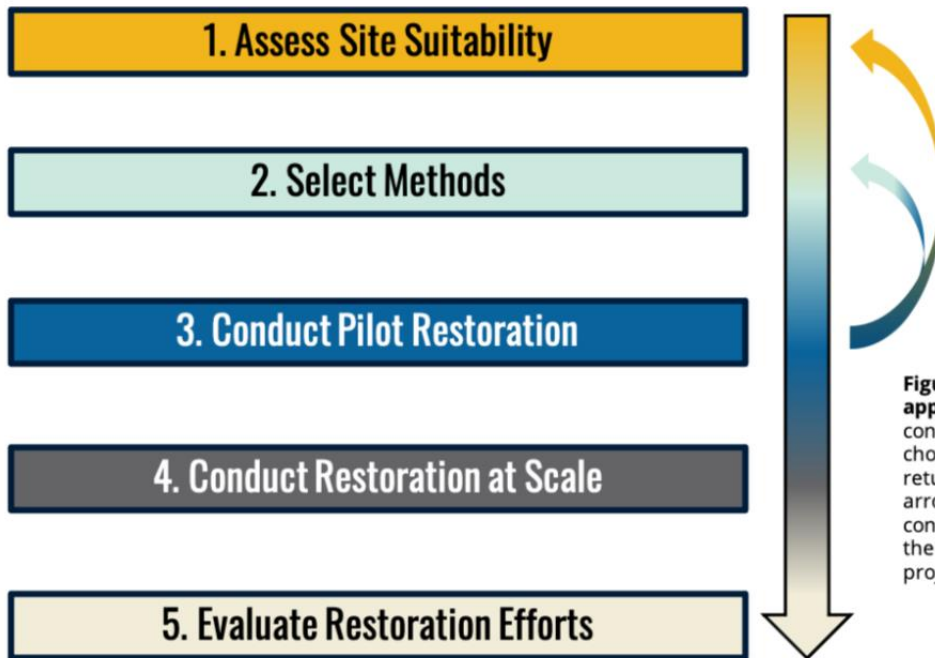
Figure 9. The five steps in the recommended approach to eelgrass restoration. Once a pilot is conducted, practitioners may have to reassess the chosen method (signified by the curved arrow returning to Step 2) or site (signified by the curved arrow returning to Step 1). A project should only continue moving forward if there is evidence that the site and method are appropriate for meeting project objectives.

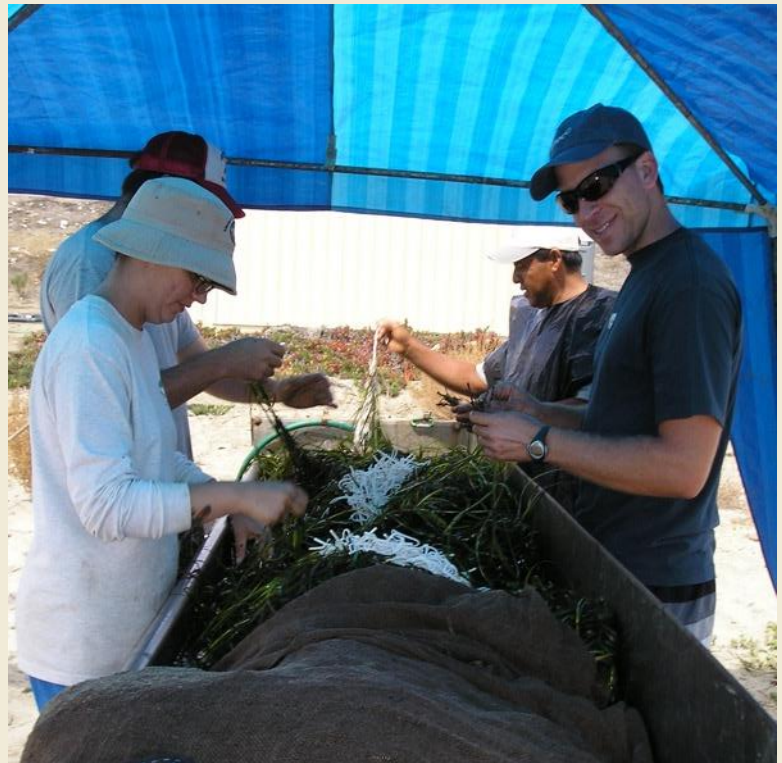
Merkel and Associates preparing shoots for transplanting using the 'Merkel Paper Stick Method'.

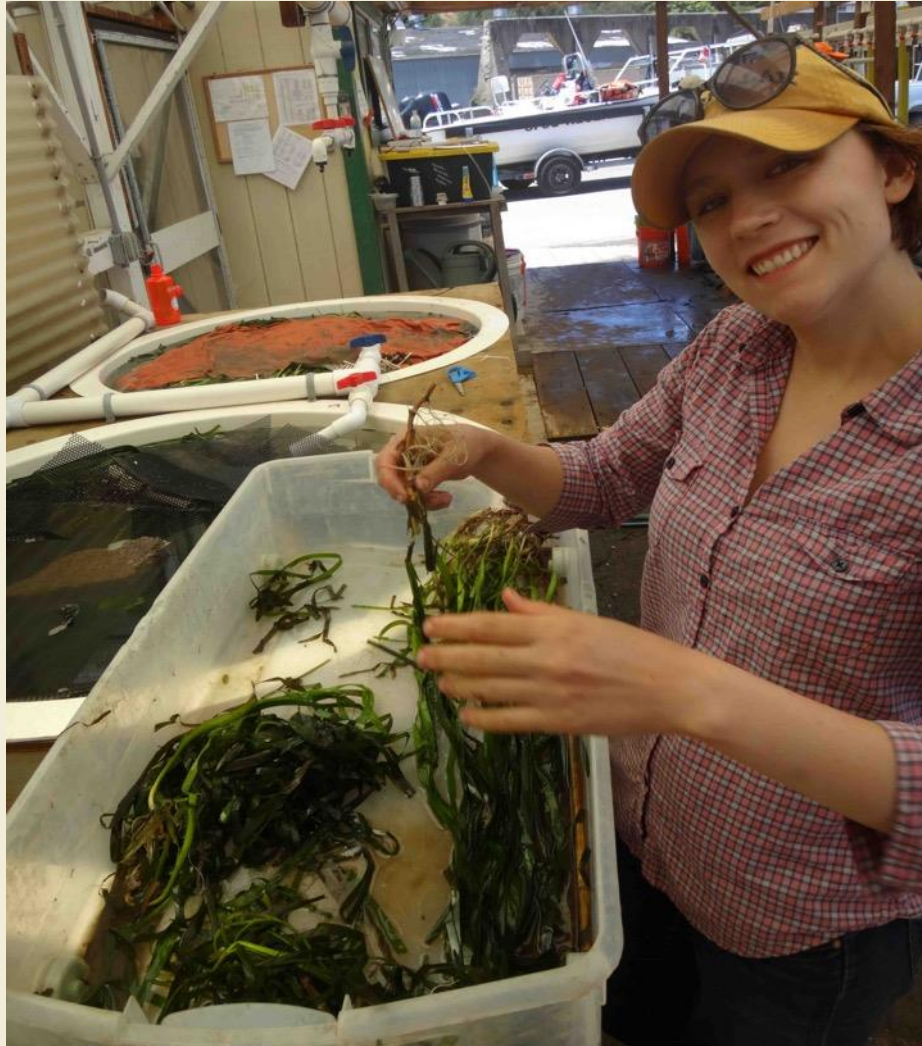
**Rigging transplant units at the Estuary & Ocean Science Center,
Tiburon. Photo Kathy Boyer**

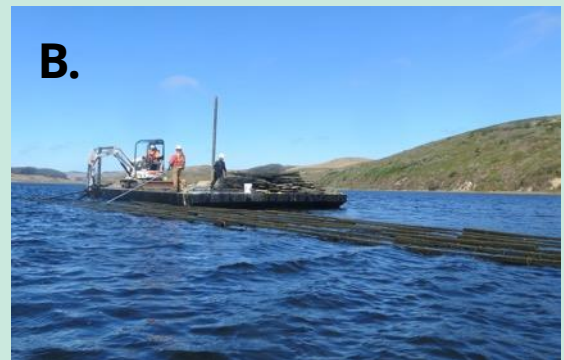
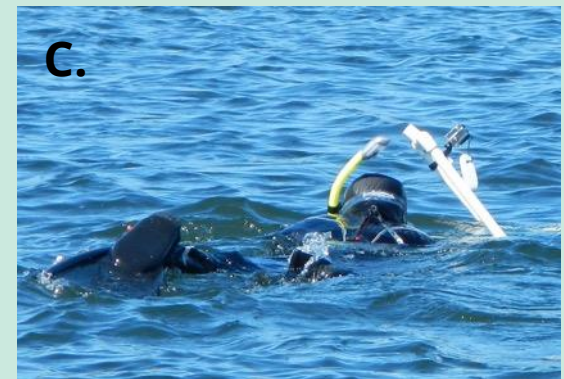
Excavator removed mariculture debris from the estuary (A-B) and the Research team conducted snorkel-based surveys of the restoration plots before and after the restoration, pictured here holding the photo-quadrat rig. Photos: NPS

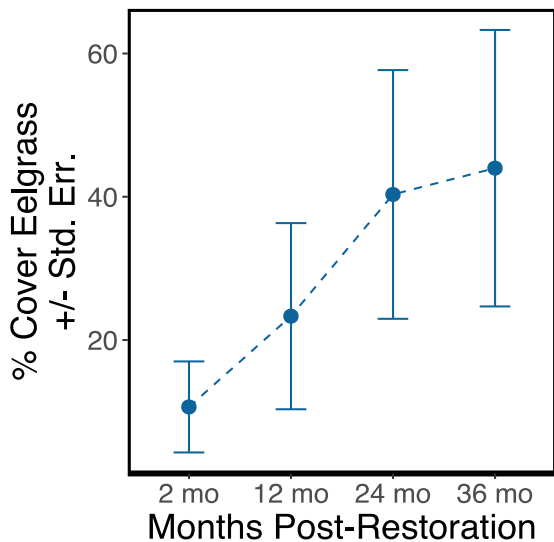
Cover has been steadily increasing over the past 3 years.

Outcomes: Overall, the passive restoration was hugely successful in minimizing impacts and facilitating natural eelgrass recovery (see Figures to the left). Impacts were limited to the footprint of the project area and the impact to eelgrass was far below what was permitted (2390 m² or 25,730 ft²) at only 353 m² (3,803 ft²) [1]. The required mitigation ratio was 1.2:1 or an area of 424 m² (4,564 ft²) and by 2019, eelgrass cover increased 249% or 1057 m² (11,376 ft²) [2]. Prior to restoration, eelgrass growth was inhibited by the effects of mariculture debris, mainly through chronic shading and disturbance. Thus, by removing the debris, eelgrass was able to naturally recover into the area.

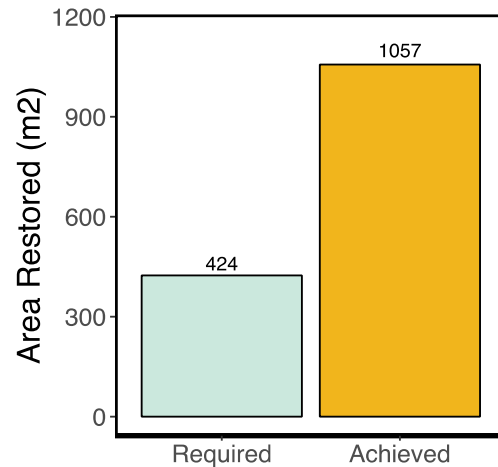
To meet the required mitigation ratio of 1.2:1, 424 m² of eelgrass habitat needed to be restored ('Required'). By 2019, 1057 m² of eelgrass habitat was restored ('Achieved')—thus, this restoration was considered a great success.

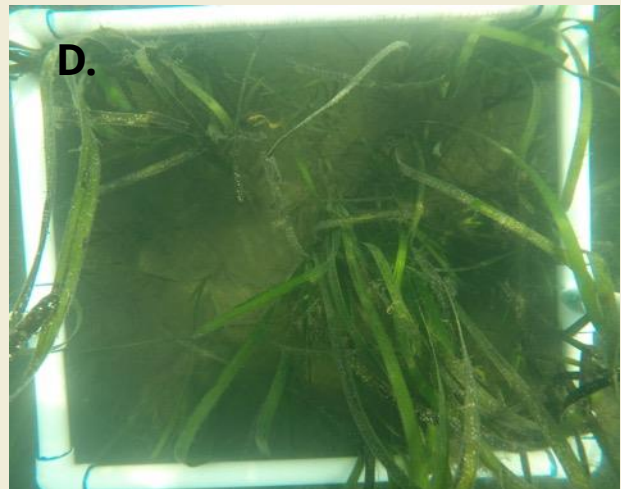
Before (A,C) and After (B,D) photo quadrats from a single plot surveyed in 2016 (A) and 2019 (B). Photos: NPS

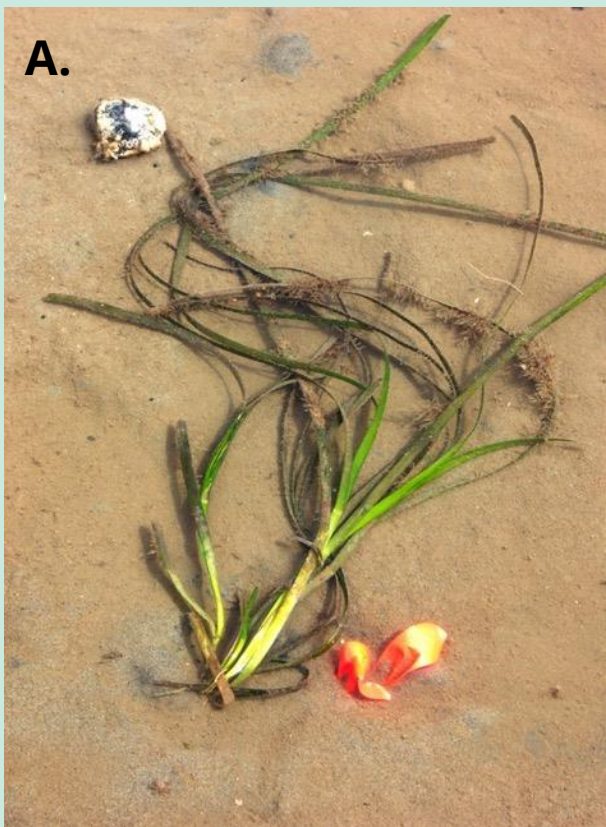
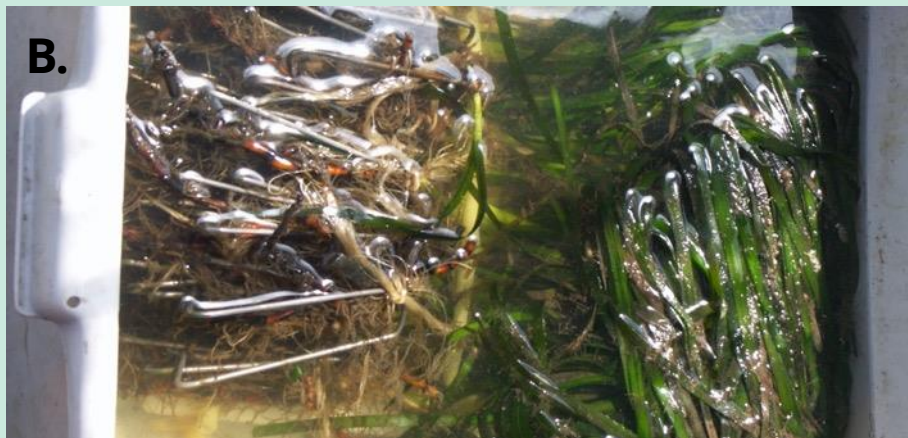
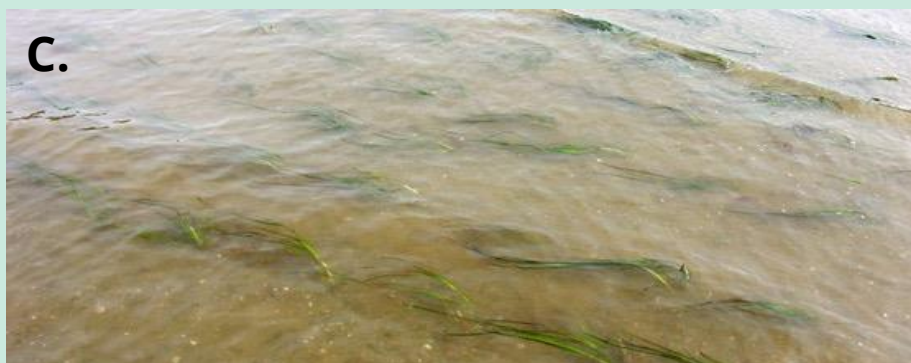
Transplanted shoots A) prepared in bundled with 6" garden staple, B) transplanted in the intertidal, C) organized in rows. Photos: Jason Stutes
